CFV Labs

FEBRUARY 12, 2020

Testing for Crack Susceptibility in c-Si Cells Using SMLT+DMLT Sequence

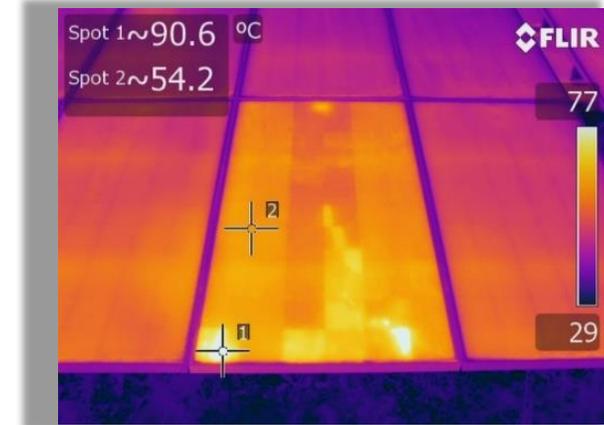
Infrared image showing hotspots on electrically isolated cell sections

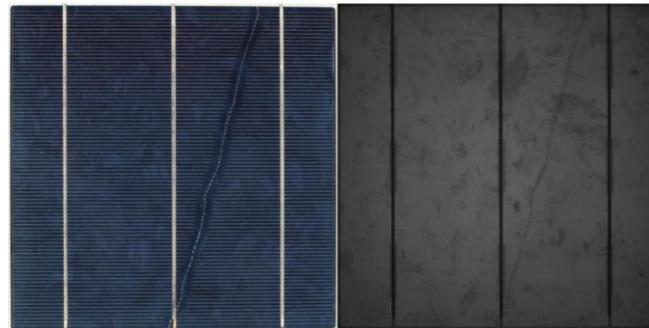
Visual and EL images show a snail trail tracing a crack

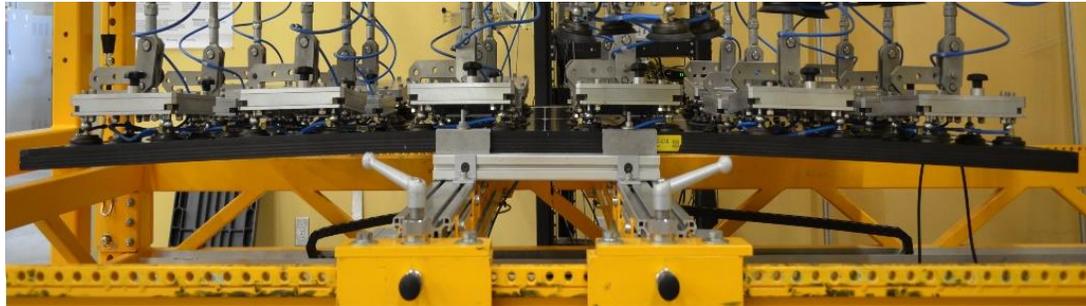
- Cell Type: 5BB Mono-PERC
- Cell count: 72
- Frame Thickness: **< 35 mm**
- Power Class: 350 W
- Glass with Backsheet
- Prone to cracking, per our experience

Center Point Deflection = 47 mm

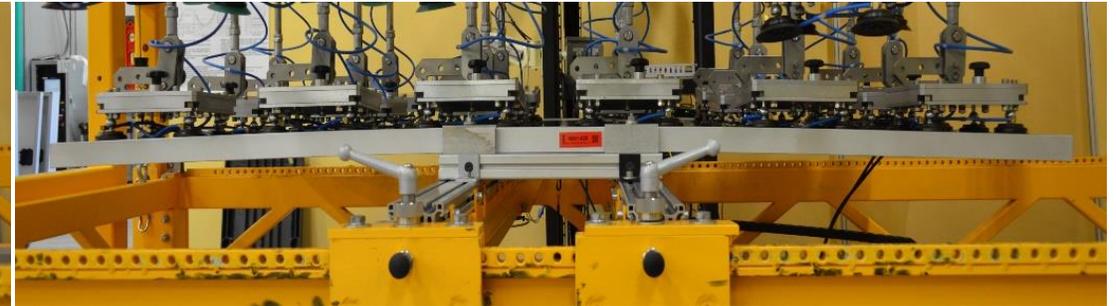
- Cell Type: 4BB Mono-PERC
- Cell count: 72
- Frame Thickness: **40 mm**
- Power Class: 360 W
- Glass with Backsheet

Center Point Deflection = 32 mm
